North Coast Integrated Regional Water Management Plan Proposition 84 Round 1 Implementation Grant

Priority Project Technical Documents: Plans and Specifications

444 - Mattole Integrated Watershed Management Initiative, Mattole Restoration Council

Mattole Flow Program: Water Storage and Forbearance Conceptual Plan

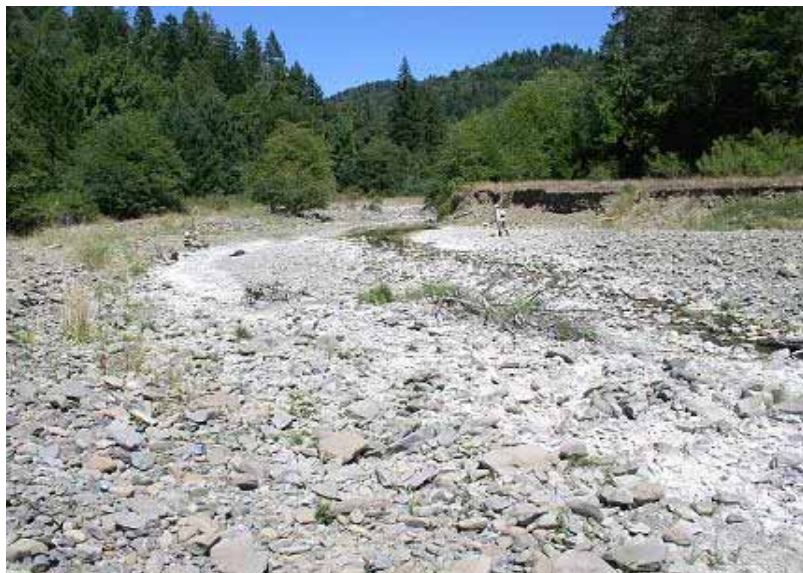
Figure IV-4.1: Mattole Canyon Creek: High sediment loads, poor conditions for natural establishment of riparian vegetation.

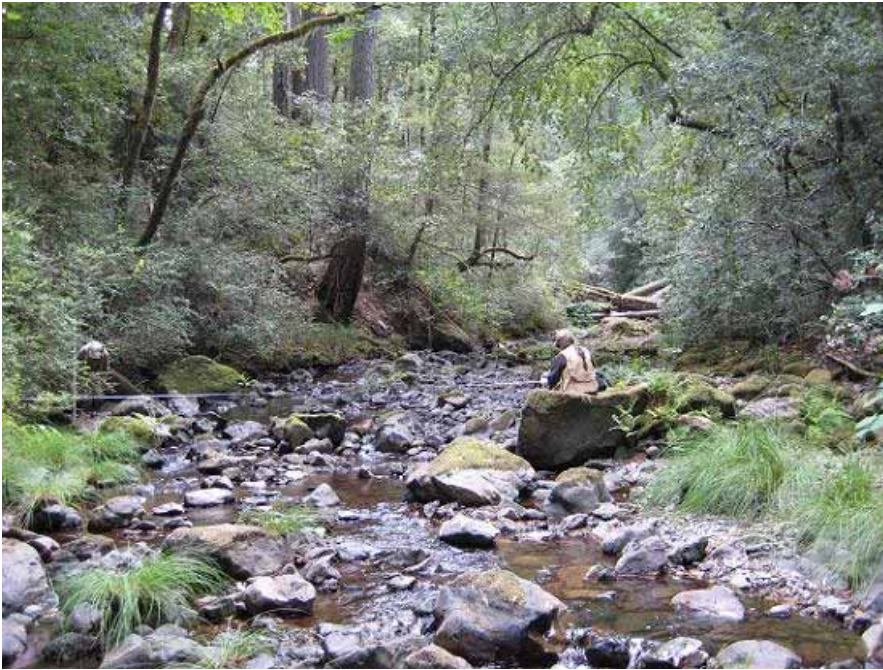
Figure IV-4.2: South Fork Bear Creek: Mature riparian vegetation in the King Range National Conservation Area. Note large Douglas-fir, understory, and log jam in background.

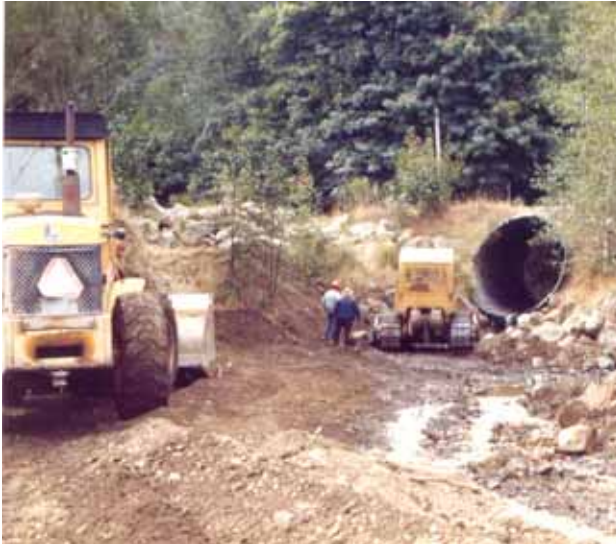
Figure 2: Mill Creek culvert. MRC Photo

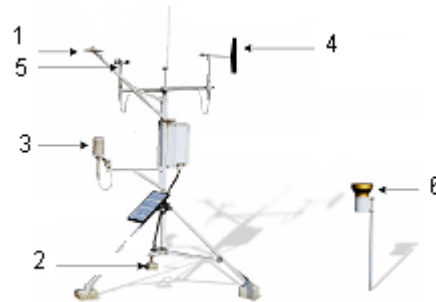
1. Total solar radiation (pyranometer)
2. Soil temperature (thermistor)
3. Air temperature/relative humidity (HMP35)
4. Wind direction (wind vane)
5. Wind speed (anemometer)
6. Precipitation (tipping-bucket rain gauge)

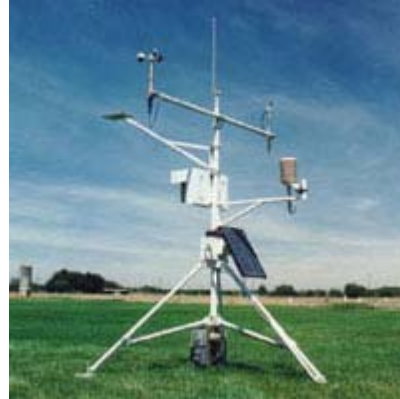
The placement of a weather station and the local environment of a weather station site can affect the utility and accuracy of ETo (calculated using the stations' weather data) for the area in which it is located. Buildings or trees close enough to a weather station can affect wind speed data, which in turn affects the resultant calculated ETo. The absence of a healthy green grass under a weather station can affect net radiation severely and humidity to some degree, which will adversely affect ETo. Bare soil instead of cropped land around the weather station can increase advected energy, increasing temperatures and decreasing humidities, which would increase the ETo value.

A CIMIS weather station should be located within the area that the station is meant to represent. The overriding factor in locating any CIMIS weather station is that the station location should be representative of the largest possible surrounding area. This will insure the most efficient use of weather stations for supplying accurate and applicable ETo information. The ideal site for a CIMIS weather station would be located in a 20-acre or larger pasture that is well maintained. The actual weather station would be located in the center of the pasture, inside a 10-yard to by 10-yard fenced enclosure. Inside the enclosure, the grass would also be well maintained (properly irrigated and fertilized) and mowed frequently to maintain a height between three to six inches.
